# My rotor is leaking around the riser stem, is there something I can replace or repair to fix this?

## Replacing the Riser Seal on a Hunter rotor

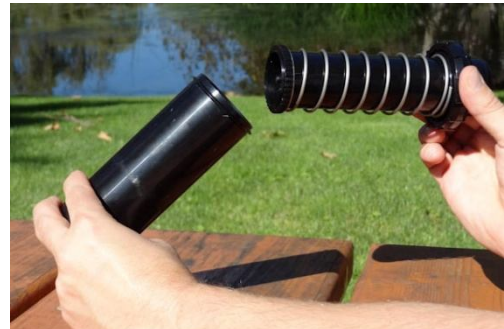
**Step One**

Unthread the body cap and remove the internal assembly from the pop-up body.

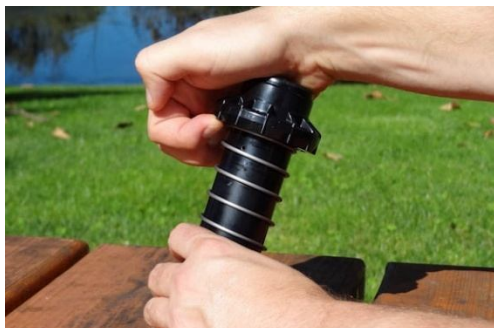
**Step Two**

Place the base of the riser on a solid surface and grip the spring and riser body firmly. With the other hand, snap off the body cap with your palm on top of the logo cap, pull up with your fingers.

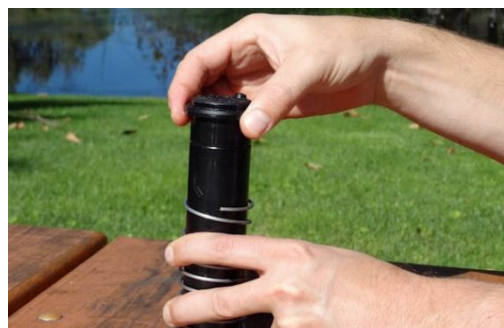
### Step Three =>

While still gripping the spring and body, remove the rubber seal.

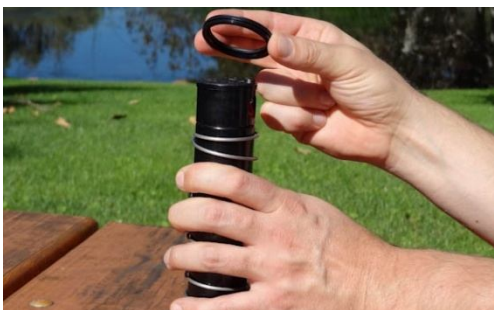
### <= Step Four

When you remove the seal, the spring's tension will be released. Remove the plastic spring and plastic spring seat

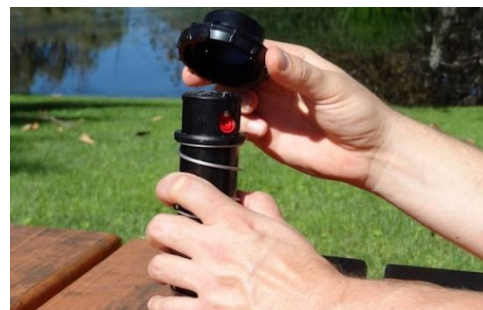
**Step Five**

Now that the old seal is removed, the new seals and plastic spring seat can slide over the top of the rotor's turret and onto the riser. Be sure to install the spring seat prior to the riser seal. After the new components are installed you can then reinstall the rotors body cap.
